**Flood Control Project Maintenance
Levee Inspections**

Maintenance Issue Types Only, Levee Inspection Report By Mile - Spring 2019

Sutter Maintenance Yard East Levee Sutter Bypass

Waterway	Bank	Unit Miles	Inspection Start/End	Inspector
Unit No. 01 Sutter Bypass Levee	Left	21.68	05/08/2019 05/08/2019	Makar Sokol

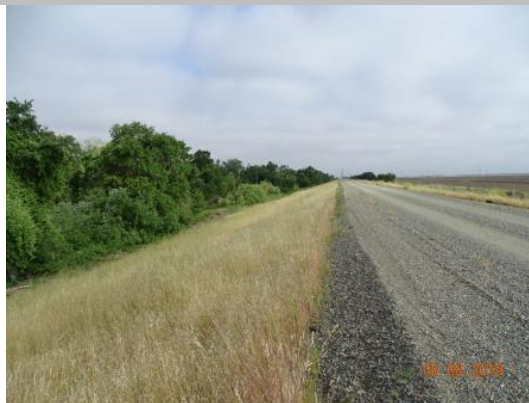
Photo 1 of 1 : SP_2019_ST0002_450_3_20190510_00083.jpg

LM Start	0.01	Rating **	U	Issue No.	3
LM End	21.78	Issue Type +	Ma	Location *	WS
Category	Earthen Levee			GPS Latitude/Longitude	
				Start	End
Item	Vegetation			39.151161 °	38.898027 °
				-121.832001 °	-121.617900 °
DWR ID	DWR_ST0002_01_s_2012_3				
Comment Code					
V1 : Control annual grass and weeds on the levee slopes and easements.					
Inspector Comment

View of the vegetation on the waterside slope. Spring 2019.

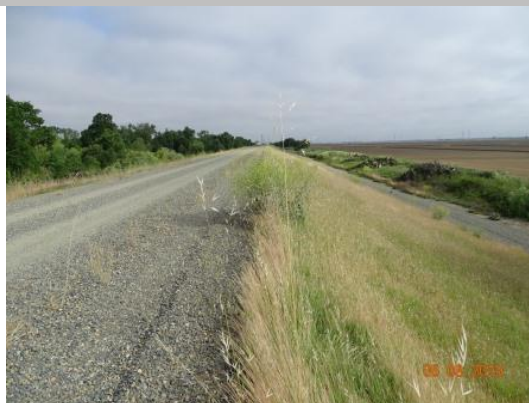
Photo 1 of 1 : SP_2019_ST0002_450_2_20190510_00084.jpg

LM Start	0.01	Rating **	U	Issue No.	2
LM End	21.78	Issue Type +	Ma	Location *	LS
Category	Earthen Levee			GPS Latitude/Longitude	
				Start	End
Item	Vegetation			39.151161 °	38.898028 °
				-121.832000 °	-121.617900 °
DWR ID	DWR_ST0002_01_s_2012_2				
Comment Code					
V1 : Control annual grass and weeds on the levee slopes and easements.					
Inspector Comment

View of the vegetation on the landside slope. Spring 2019.

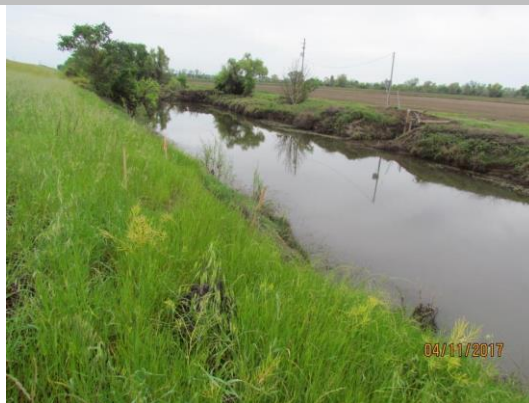
Photo 1 of 1 : SP_2019_ST0002_450_42_20190327_00009.jpg

LM Start	0.36	Rating **	M	Issue No.	42
LM End	0.36	Issue Type +	Ma	Location *	WS
Category	Earthen Levee			GPS Latitude/Longitude	
				Start	End
Item	Erosion / Bank Caving			39.147183 °	39.147183 °
				-121.828142 °	-121.828142 °
DWR ID	DWR_ST0002_01_s_2017_42				
Comment Code					
E2 : Schedule repair of erosion site prior to the next inspection.					
Inspector Comment					
Repair the erosion along the waterside toe.

View of the erosion along the waterside toe.

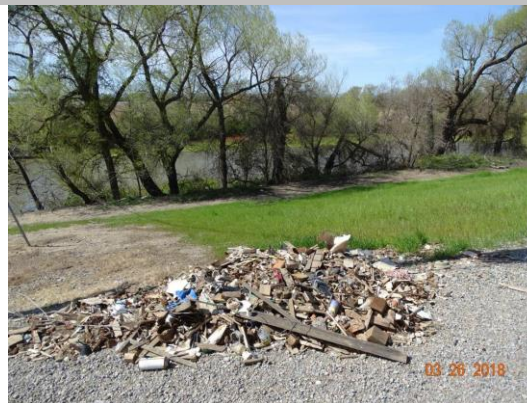
Photo 1 of 1 : SP_2019_ST0002_450_46_20190327_00012.jpg

View of the garbage along the waterside slope.

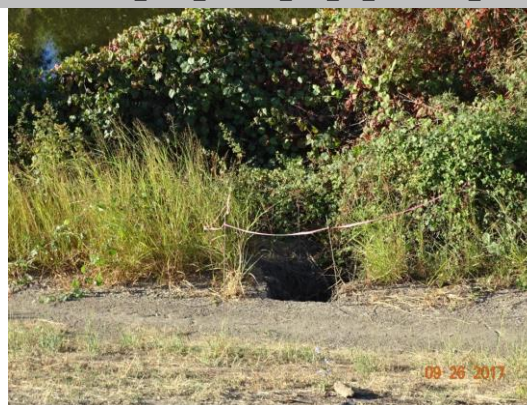
Photo 1 of 1 : SP_2019_ST0002_450_57_20190327_00013.jpg

LM Start	1.53	Rating **	U	Issue No.	57
LM End	1.53	Issue Type +	Ma	Location *	WS
Category	Earthen Levee			GPS Latitude/Longitude	
				Start	End
Item	Erosion / Bank Caving			39.137373 °	39.137373 °
				-121.810382 °	-121.810382 °
DWR ID	DWR_ST0002_01_f_2017_57				
Comment Code					
E2 : Schedule repair of erosion site prior to the next inspection.					
Inspector Comment					
Repair the beaver hole along the waterside berm.

View of the beaver hole along the waterside berm.

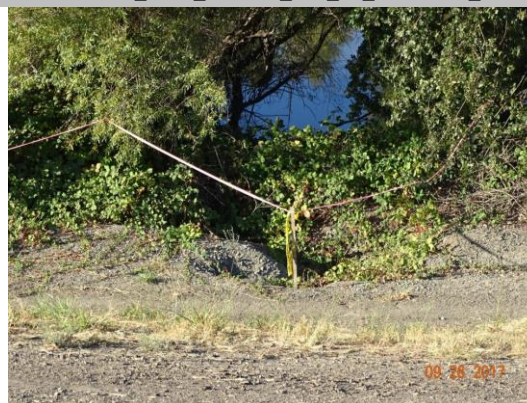
Photo 1 of 1 : SP_2019_ST0002_450_58_20190327_00014.jpg

LM Start	1.57	Rating **	U	Issue No.	58
LM End	1.57	Issue Type +	Ma	Location *	WS
Category	Earthen Levee			GPS Latitude/Longitude	
				Start	End
Item	Erosion / Bank Caving			39.137010 °	39.137010 °
				-121.809673 °	-121.809673 °
DWR ID	DWR_ST0002_01_f_2017_58				
Comment Code					
E2 : Schedule repair of erosion site prior to the next inspection.					
Inspector Comment					
Repair the beaver hole along the waterside berm.

View of the beaver hole along the waterside berm.

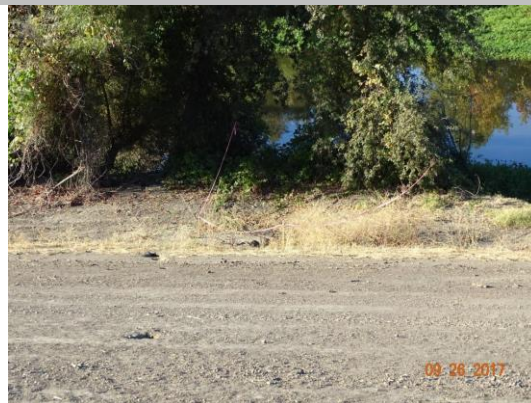
Photo 1 of 1 : SP_2019_ST0002_450_61_20190327_00015.jpg

LM Start	1.61	Rating **	U	Issue No.	61
LM End	1.61	Issue Type +	Ma	Location *	WS
Category	Earthen Levee			GPS Latitude/Longitude	
				Start	End
Item	Erosion / Bank Caving			39.136713 °	39.136713 °
				-121.809202 °	-121.809202 °
DWR ID	DWR_ST0002_01_f_2017_61				
Comment Code					
E2 : Schedule repair of erosion site prior to the next inspection.					
Inspector Comment					
Repair the beaver hole along the waterside berm.

View of the beaver hole along the waterside berm.

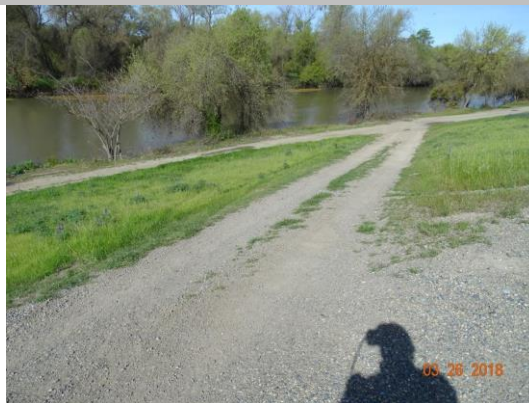
Photo 1 of 1 : SP_2019_ST0002_450_45_20190327_00011.jpg

LM Start	5.19	Rating **	M	Issue No.	45
LM End	5.19	Issue Type +	Ma	Location *	WS
Category	Earthen Levee			GPS Latitude/Longitude	
				Start	End
Item	Slope Stability			39.103368 °	39.103368 °
				-121.758760 °	-121.758760 °
DWR ID	DWR_ST0002_01_s_2018_45				
Comment Code					
S3 : Repair the levee slope damaged by vehicle traffic and prevent access where possible.					
Inspector Comment

View of the vehicle traffic along the waterside slope.

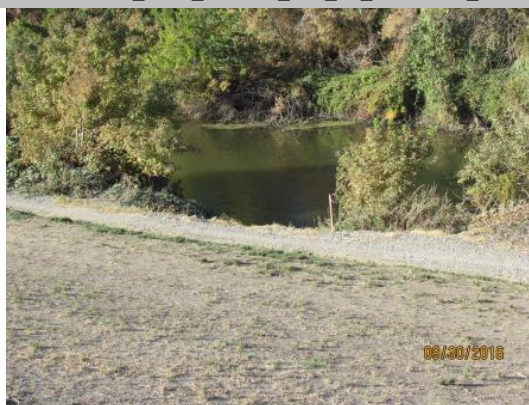
Photo 1 of 1 : SP_2019_ST0002_450_34_20190327_00007.jpg

LM Start	7.83	Rating **	A/W	Issue No.	34
LM End	7.83	Issue Type +	Ma	Location *	WS
Category	Earthen Levee			GPS Latitude/Longitude	
				Start	End
Item	Erosion / Bank Caving			39.067299 °	39.067299 °
				-121.742851 °	-121.742851 °
DWR ID	DWR_ST0002_01_f_2016_34				
Comment Code					
E1 : Note and monitor erosion site.					
Inspector Comment

View of the erosion along the waterside toe.

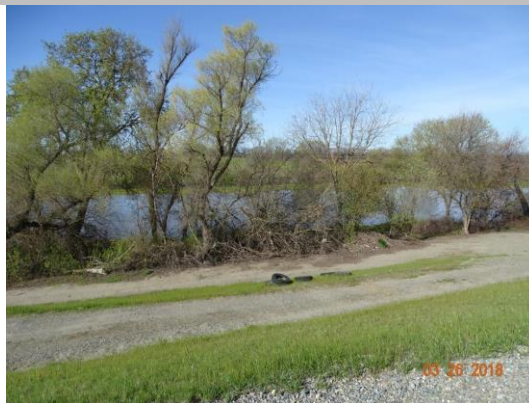
Photo 1 of 1 : SP_2019_ST0002_450_44_20190327_00010.jpg

View of the tires along the waterside slope and toe.

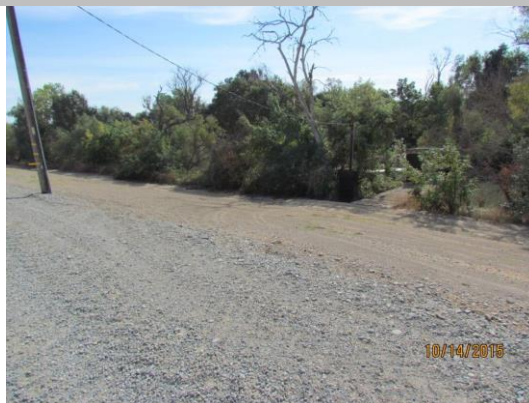
Photo 1 of 1 : SP_2019_ST0002_450_23_20190327_00004.jpg

LM Start	13.34	Rating **	A/W	Issue No.	23
LM End	13.34	Issue Type +	Ma	Location *	WS
Category	Earthen Levee			GPS Latitude/Longitude	
				Start	End
Item	Slope Stability			38.991857 °	38.991857 °
				-121.711555 °	-121.711555 °
DWR ID	DWR_ST0002_01_s_2015_23				
Comment Code					
S3 : Repair the levee slope damaged by vehicle traffic and prevent access where possible.					
Inspector Comment					
Monitor the erosion along the waterside slope.

View of the vehicle erosion along the slope.

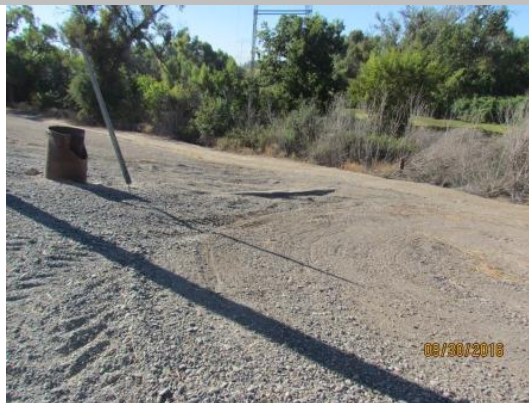
Photo 1 of 1 : SP_2019_ST0002_450_37_20190327_00008.jpg

LM Start	14.71	Rating **	M	Issue No.	37
LM End	14.71	Issue Type +	Ma	Location *	WS
Category	Earthen Levee			GPS Latitude/Longitude	
				Start	End
Item	Slope Stability			38.979389 °	38.979389 °
				-121.691923 °	-121.691923 °
DWR ID	DWR_ST0002_01_f_2016_37				
Comment Code					
S3 : Repair the levee slope damaged by vehicle traffic and prevent access where possible.					
Inspector Comment

View of the erosion caused by vehicle traffic.

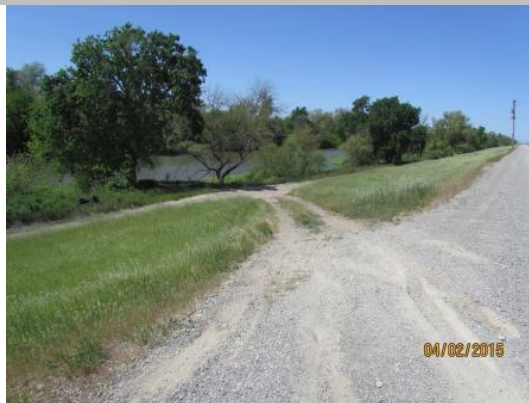
Photo 1 of 2 : SP_2019_ST0002_450_21_20190327_00002.jpg

LM Start	17.60	Rating **	M	Issue No.	21
LM End	17.60	Issue Type +	Ma	Location *	WS
Category	Earthen Levee			GPS Latitude/Longitude	
				Start	End
Item	Slope Stability			38.949965 °	38.949965 °
				-121.653823 °	-121.653823 °
DWR ID	DWR_ST0002_01_s_2015_21				
Comment Code					
S3 : Repair the levee slope damaged by vehicle traffic and prevent access where possible.					
Inspector Comment

View of the vehicle erosion along the waterside slope.

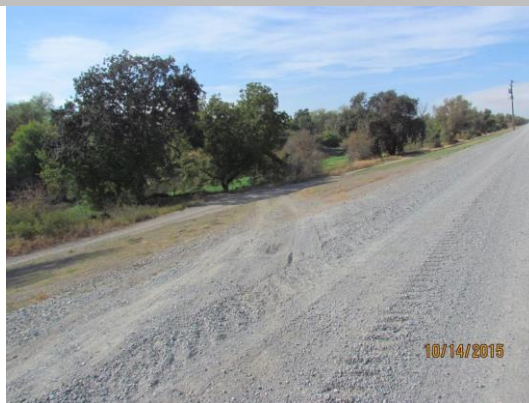
Photo 2 of 2 : SP_2019_ST0002_450_21_20190327_00003.jpg

View of the vehicle erosion along the waterside slope.

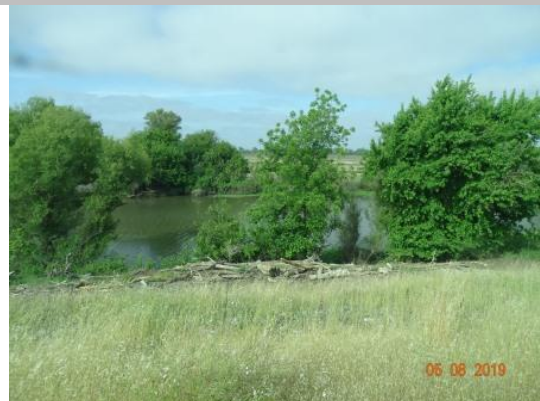
Photo 1 of 1 : SP_2019_ST0002_450_50_20190510_00085.jpg

View of tree trunks and limbs at the waterside toe. Spring 2019.

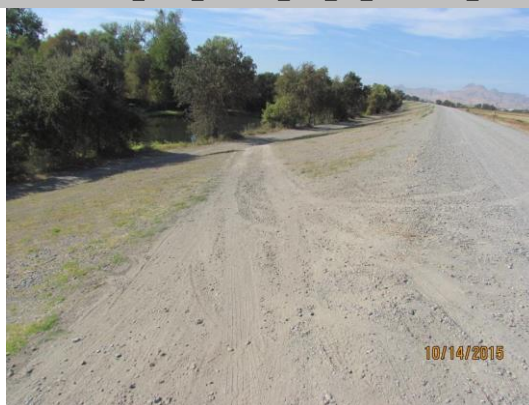
Photo 1 of 1 : SP_2019_ST0002_450_29_20190327_00006.jpg

View of the vehicle erosion along the waterside slope.
